**PARC PENDRE  
FFORDD LAS  
PRESTATYN  
DENBIGHSHIRE  
LL19 9SG**

**VISUAL TREE ASSESSMENT**

**Stephen Cutmore** BSc (Hons), MICFor, MARborA, VETcert Consulting Level  
Chartered Arboriculturist

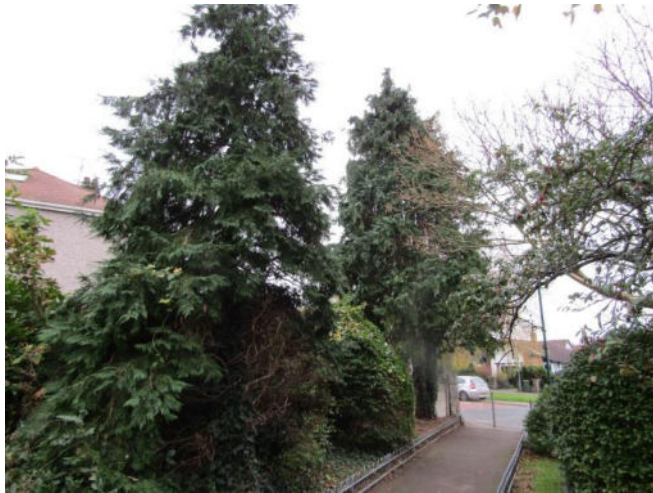
Photo 1: R-L Cypress (T1, T2, T4).

| Tree No. | Species | Age Class | Height (m) | Stem Diameter at 1.5m (mm) | Crown spread (m) | Physiological condition | Structural condition | Preliminary management recommendations | Priority for Action |
|---|---|---|---|---|---|---|---|---|---|
| T1 | Sawara Cypress | M | 11 | 220/270/230/270 | 4 | Good | Multi-stemmed at base.<br>Ivy at base of trunks.<br>Small deadwood. | Sever Ivy at base. | Low |
| T2 | Sawara Cypress | M | 11 | 270 | 3 | Good | Co-dominant fork at 3m with included bark.<br>Small deadwood. | No work required. | Low |
| T4 | Sawara Cypress | S/M | 6 | 180 | 3 | Good | Ivy up trunk into crown. | Sever Ivy at base. | Low |

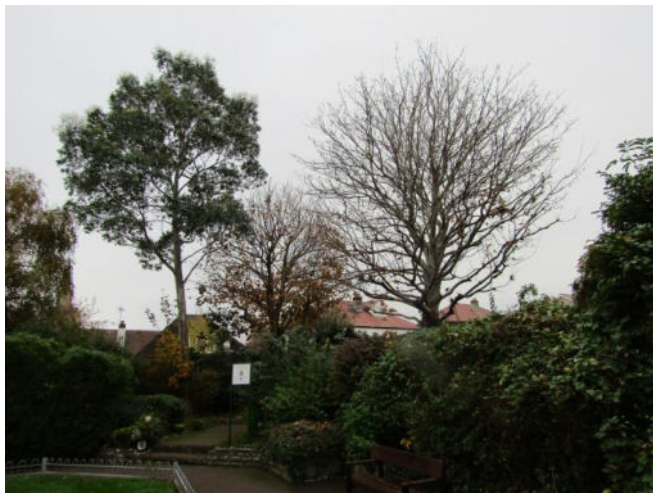
Photo 2: R-L Purple Norway Maples (T5-6), Cider Gum (T7).

The Cider Gum (T7) has a tall slender trunk and is leaning slightly to the North, towards the garage on the neighbour's land. To control the size of the crown and to minimise the risk of future branch failure, consideration should be given to reducing the height by 2m and radial spread of the branches by 1m (**medium** priority).

| Tree No. | Species | Age Class | Height (m) | Stem Diameter at 1.5m (mm) | Crown spread (m) | Physiological condition | Structural condition | Preliminary management recommendations | Priority for Action |
|---|---|---|---|---|---|---|---|---|---|
| T5 | Purple Norway Maple | M | 11 | 440 | 10 | Good | Previously crown lifted to clear above neighbour's shed.<br>Small deadwood. | No work required | Low |
| T6 | Purple Norway Maple | M | 10 | 580 | 10 | Good | Previously crown lifted.<br>Small deadwood. | No work required | Low |
| T7 | Cider Gum | M | 13 | 420 | 6 | Good | Tall slender trunk, with weight towards neighbouring garden.<br>Bark splits on lower trunk, due to rapid growth.<br>Small deadwood. | Consider crown reducing (by 2m in height and 1m branch reduction) to control size. | Medium |

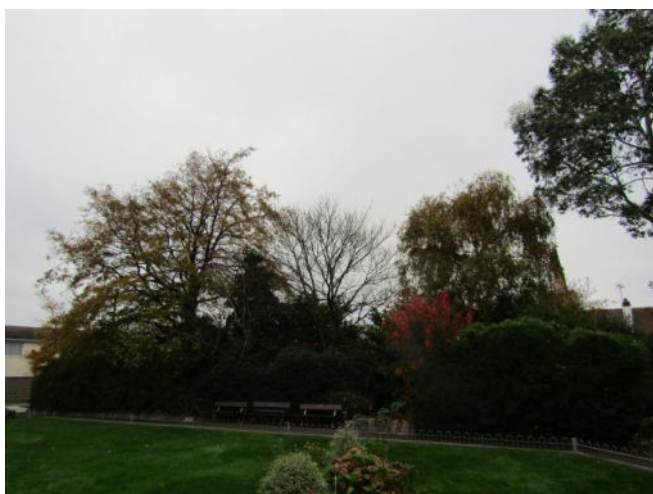
Photo 3: R-L Birch (T9), Norway Maple (T10), Cypress (T11), Turkey Oak (T13).

| Tree No. | Species | Age Class | Height (m) | Stem Diameter at 1.5m (mm) | Crown spread (m) | Physiological condition | Structural condition | Preliminary management recommendations | Priority for Action |
|---|---|---|---|---|---|---|---|---|---|
| T9 | Silver Birch | M | 9 | 280 | 6 | Good | Trunk leans slightly towards garage. | No work required. | Low |

| Tree No. | Species | Age Class | Height (m) | Stem Diameter at 1.5m (mm) | Crown spread (m) | Physiological condition | Structural condition | Preliminary management recommendations | Priority for Action |
|---|---|---|---|---|---|---|---|---|---|
| T10 | Variegated Norway Maple | E/M | 10 | 290 | 8 | Good | Ivy up trunk into crown.<br>Small deadwood. | Sever Ivy at base | Low |
| T11 | Sawara Cypress | S/M | 7 | 190 | 3 | Good | Small deadwood. | No work required. | Low |

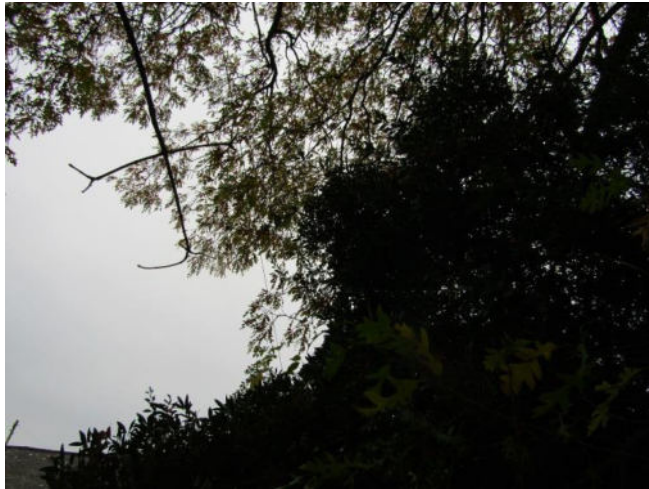
| Tree No. | Species | Age Class | Height (m) | Stem Diameter at 1.5m (mm) | Crown spread (m) | Physiological condition | Structural condition | Preliminary management recommendations | Priority for Action |
|---|---|---|---|---|---|---|---|---|---|
| T13 | Turkey Oak | M | 13 | 560 | 14 | Good | Ivy at base.<br>Small deadwood.<br>Branches close to BT phone lines. | Sever Ivy at base.<br>Prune branches back to a suitable growth point to provide 1m clearance from BT lines. | Medium |

Photo 4: Branches of Turkey Oak (T13) close to BT phone lines.

The Turkey Oak (T13) and the Sycamore (T14) have branches in close proximity to the BT phone lines. The recommendation is to prune the branches back to a suitable growth point, to provide a 1m clearance from the BT phone lines (**medium** priority).

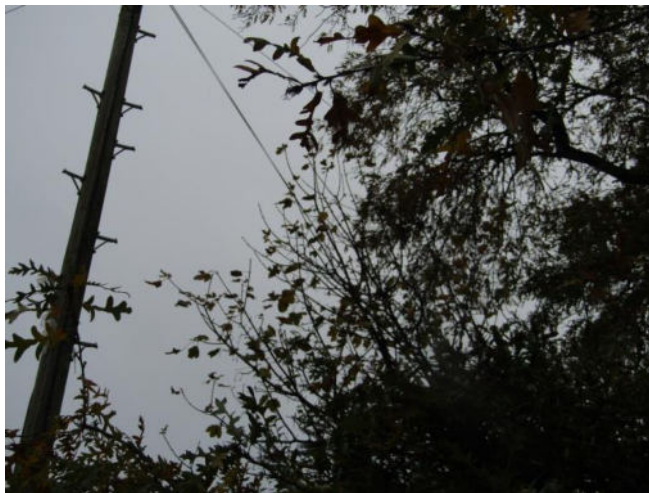
| Tree No. | Species | Age Class | Height (m) | Stem Diameter at 1.5m (mm) | Crown spread (m) | Physiological condition | Structural condition | Preliminary management recommendations | Priority for Action |
|---|---|---|---|---|---|---|---|---|---|
| T14 | Sycamore | S/M | 7 | 140 | 3 | Good | Small tree growing adjacent to boundary with garage.<br>Branches close to BT phone lines. | Prune branches back to a suitable growth point to provide 1m clearance from BT lines. | Medium |

Photo 5: Branches of Sycamore (T14) close to BT phone lines.

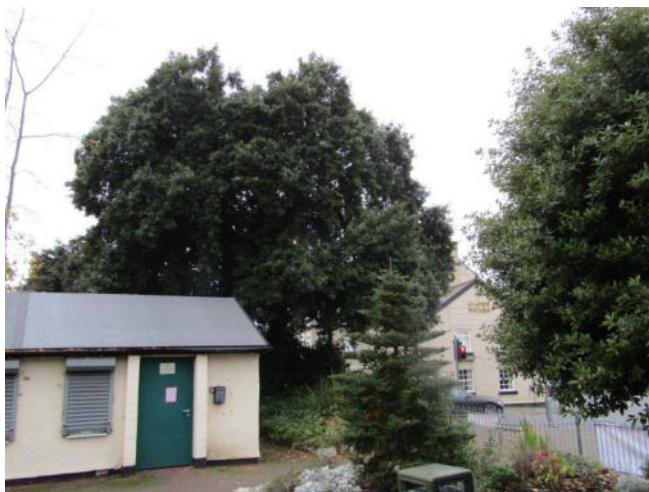
Photo 6: R-L Holm Oak (T15), Korean Fir (T16), Holm Oak (T17).

| Tree No. | Species | Age Class | Height (m) | Stem Diameter at 1.5m (mm) | Crown spread (m) | Physiological condition | Structural condition | Preliminary management recommendations | Priority for Action |
|---|---|---|---|---|---|---|---|---|---|
| T15 | Holm Oak | E/M | 4 | 290 | 4 | Good | Regularly trimmed into globe shape.<br>Previously crown lifted. | No work required. | Low |
| T16 | Korean Fir | Y | 2 | 80 | 2 | Good | Small young tree establishing. | No work required. | Low |
| T17 | Holm Oak | M | 13 | 770 | 14 | Fair | Low branches close to road signs.<br>Fairy lights installed in crown.<br>Deadwood previously removed.<br>Low branches close to BT phone lines. | Prune branches back to a suitable growth point to provide 1m clearance from BT lines and from road sign. | Medium |

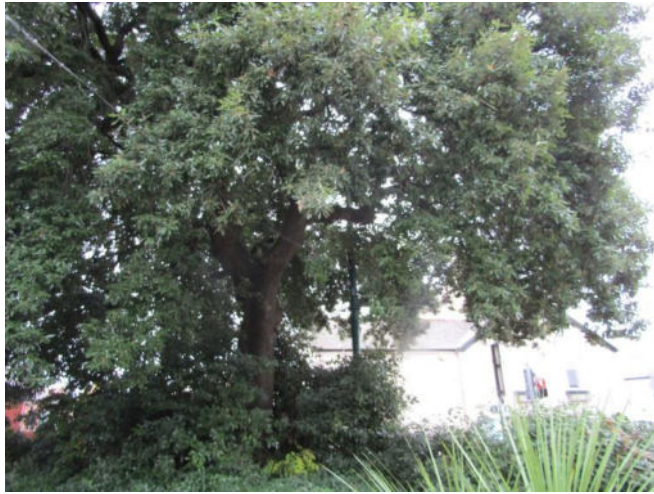
Photo 7: Branches of Holm Oak (T17) close to BT phone lines and road sign.

The Holm Oak (T17) has some lower branches in close proximity to the road traffic sign and the BT phone lines. The recommendation is to prune the branches back to a suitable growth point, to provide a 1m clearance from the BT phone lines and road traffic sign (**medium** priority).

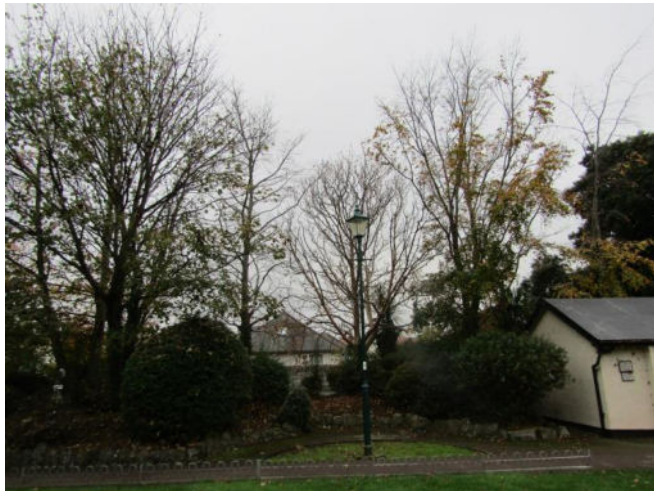
Photo 8: R-L Beech (T18-19), Ash (T20), Sycamore (T22).

| Tree No. | Species | Age Class | Height (m) | Stem Diameter at 1.5m (mm) | Crown spread (m) | Physiological condition | Structural condition | Preliminary management recommendations | Priority for Action |
|---|---|---|---|---|---|---|---|---|---|
| T18 | Beech | S/M | 11 | 260 | 4 | Good | Previously pruned to clear from roof of toilet block.<br>Co-dominant stems at 2m.<br>Ivy at base. | Sever Ivy at base. | Low |
| T19 | Beech | E/M | 13 | 380 | 6 | Good | Ivy up trunk.<br>BT line through crown.<br>Previously pruned to clear from roof of toilet block.<br>Small hanging branch. | Sever Ivy at base.<br>Remove hanging branch. | Low |
| T20 | Ash | M | 10 | 400 | 8 | Fair | Ivy up lower trunk.<br>Small dead twigs and small deadwood due to Chalara Ash Dieback Disease. | Sever Ivy at base.<br>Monitor health of crown in summer months. | Medium |
| T22 | Sycamore | E/M | 12 | 310/330/230 | 10 | Good | Multi-stemmed at base.<br>Ivy up trunks.<br>Epicormic shoots around base.<br>Small deadwood. | Sever Ivy at base.<br>Remove epicormic shoots around base. | Low |

The Beech tree (T19) has a small dead branch hanging in the crown [negligible safety risk] (**low** priority).

The Ash trees (T20 and T26) have some signs of decline in crown condition, in the form of dead twigs and small deadwood, due to Chalara Ash Dieback Disease. Due to the time of year the survey was carried out, it was not possible to accurately assess the condition of the crowns. The recommendation is to inspect the Ash trees when the leaves are fully formed in the late Spring/Summer months, using the Tree Council Health Class of Ash Dieback Crown Assessment methodology, to determine the percentage of the remaining live canopy (**medium** priority). Appropriate management recommendations can then be prescribed.

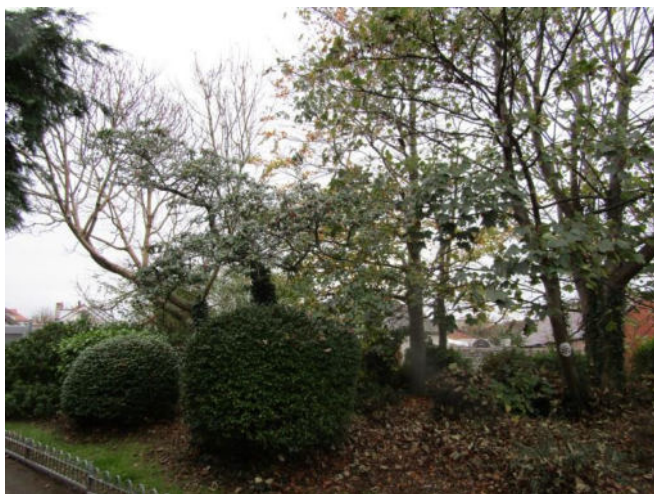
Photo 9: R-L Sycamore (T22), Beech (T23-24), Cotoneaster (T25), Ash (T26).

| Tree No. | Species | Age Class | Height (m) | Stem Diameter at 1.5m (mm) | Crown spread (m) | Physiological condition | Structural condition | Preliminary management recommendations | Priority for Action |
|---|---|---|---|---|---|---|---|---|---|
| T23 | Beech | E/M | 12 | 390 | 6 | Good | Small deadwood.<br>Ivy at base. | Sever Ivy at base. | Low |
| T24 | Beech | S/M | 10 | 220 | 3 | Good | Small deadwood. | No work required. | Low |
| T25 | Cotoneaster | M | 5 | 200 | 5 | Fair | Dead stem previously removed.<br>Ivy up into crown.<br>Epicormic shoots previously removed around base. | Sever Ivy at base. | Low |
| T26 | Ash | E/M | 7 | 360 | 9 | Fair | Ivy up into crown.<br>Small dead twigs and small deadwood due to Chalara Ash Dieback Disease. | Sever Ivy at base.<br>Monitor health of crown in summer months. | Medium |
